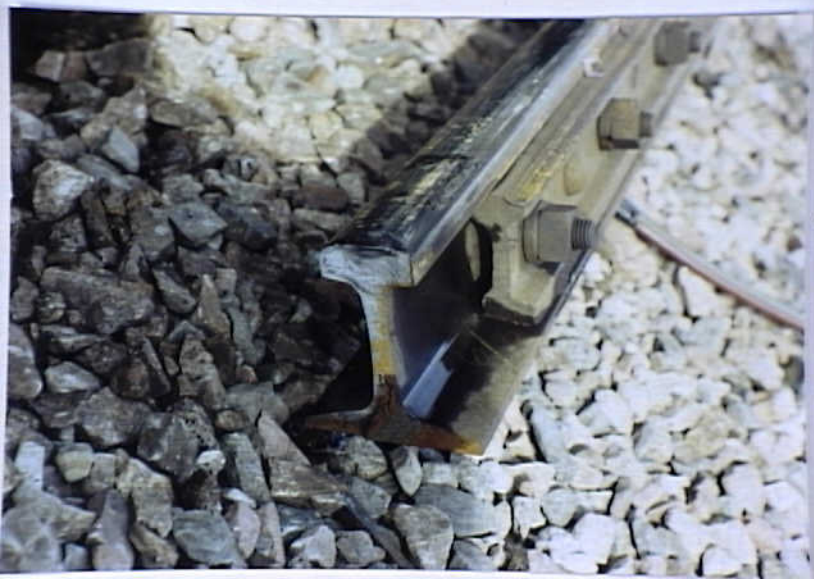
Photo 4. End view of the East end rail segment at the POD and the internal rail defect that measured 24 1/2 inches from the East end bolted rail joint
