NTSB Materials Laboratory Factual Report

MATERIALS LABORATORY FACTUAL REPORT

Report No. 01-080

Place : Nodaway, Iowa
Date : March 17, 2001
Vehicle : National Railroad Passenger Corporation
Operating Over Burlington Northern Santa Fe Railway
NTSB No. : DCA01-M-R003
Investigator : Cyril E. Gura, RPH-10

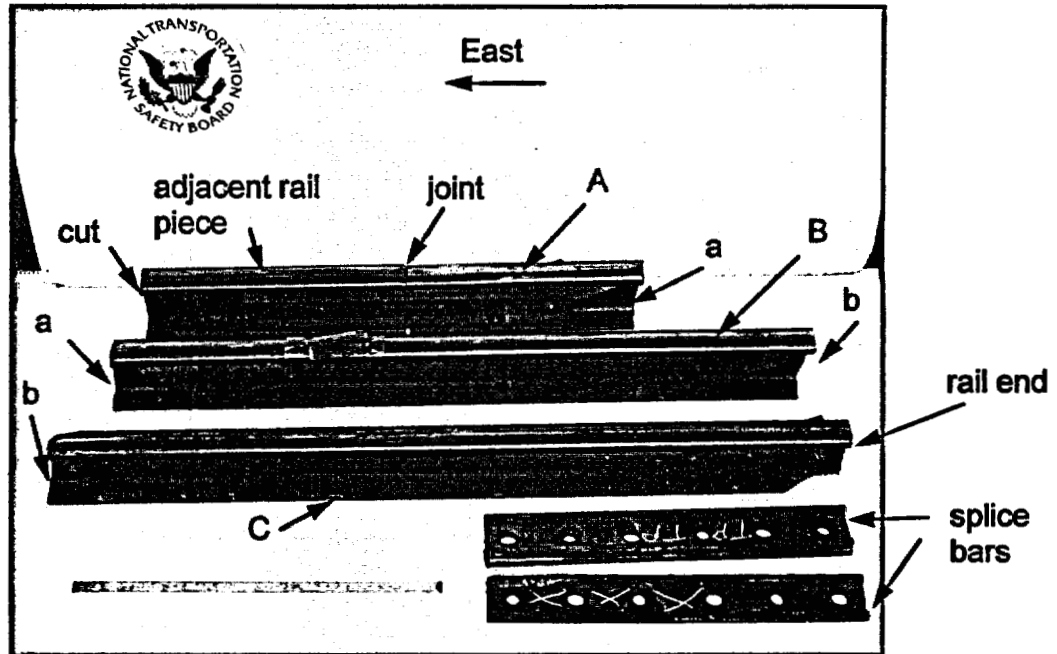
ImageNo:104A0195, Project No:A00182

The rail and splice bars were received from the south rail at the point of derailment of a westbound train. Three of the rail pieces, labeled "A" to "C" from east to west in figure 1, comprised a plug rail¹ in continuous welded rail (CWR), and the splice bars were from each end of the plug rail. The approximate lengths of pieces "A" to "C" were 29 inches, 74 inches, and 80.25 inches, respectively. Two transverse fractures were observed at locations "a" and "b". The fourth rail piece was a cut piece of the adjacent rail to the east and was joined by two splice bars to the eastern end of fractured rail piece "A". According to track maintenance records, a plug rail was installed on February 13, 2001 at the location of the derailment.

The vertical head loss was 0.188 inches, measured on pieces "B" and "C". Measurements of the gage face showed no wear. A dip was observed on the running surface at the east joint (between piece "A" and the adjacent piece of CWR rail). Over a 4-foot span, the maximum depth of the dip was approximately 0.13 inches. Marks consistent with wheel flange contact were observed on the field side splice bar at this joint, indicating a previous use. An orange-colored metal was observed on the field side of the adjacent rail heads near the joint, consistent with bond wire anchor locations. A remnant of a bond wire was also observed on the field side of the rail head near the west end of piece "C".

Figure 1. Overall view of the submitted components, where three fractured pieces of rail are lettered "A" to "C" from east to west. Fracture locations are lettered "a" and "b" from east to west..

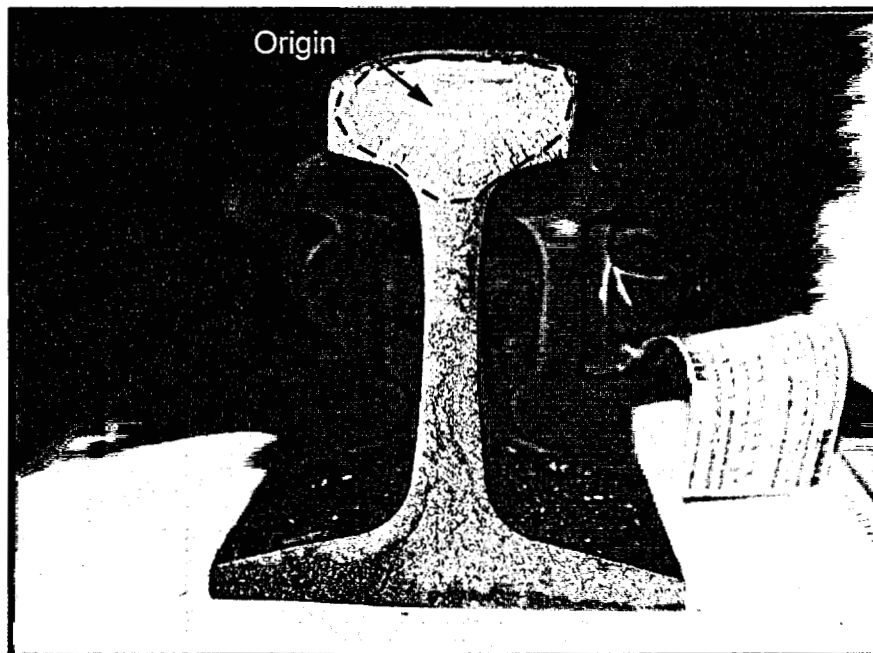
ImageNo: 104A0198, Project No:A00182

A view of the east fracture surface at location "a" is shown in figure 2. A portion of the fracture surface within the dashed-line boundary appeared relatively smooth with curving crack arrest lines, features consistent with fatigue. The fatigue features covered approximately 90 percent of the head area and emanated from an origin located 0.65 inches below the running surface and 0.01 inches toward the gage side of the centerline. A center portion of the fatigue region was noticeably smoother than the rest, having a diameter of approximately 0.5 inches centered on the origin. The remaining fracture surface outside the fatigue boundary was relatively rough with chevron marks pointing back toward the fatigue boundary, features consistent with overstress fracture initiating from the fatigue boundary. The west fracture surface at location "a" had similar features.

Deformation consistent with receiving rail end damage³ was observed on both sides of the fracture surface. On the east side, the deformation was on the upper side of the head within 0.13 inches below the running surface and within 0.97 inches east of the fracture surface. On the west side, the deformation was on the upper side of the head within 0.16 inches below the running surface and within 0.41 inches west of the fracture surface. Based on markings on the rail base, fracture "a" was determined to be located at the edge of a tie support with the centerline of the support located west of the fracture.

Figure 2. A view of the east fracture surface at location "a". An arrow and dashed line indicate the fatigue origin and boundary, respectively.

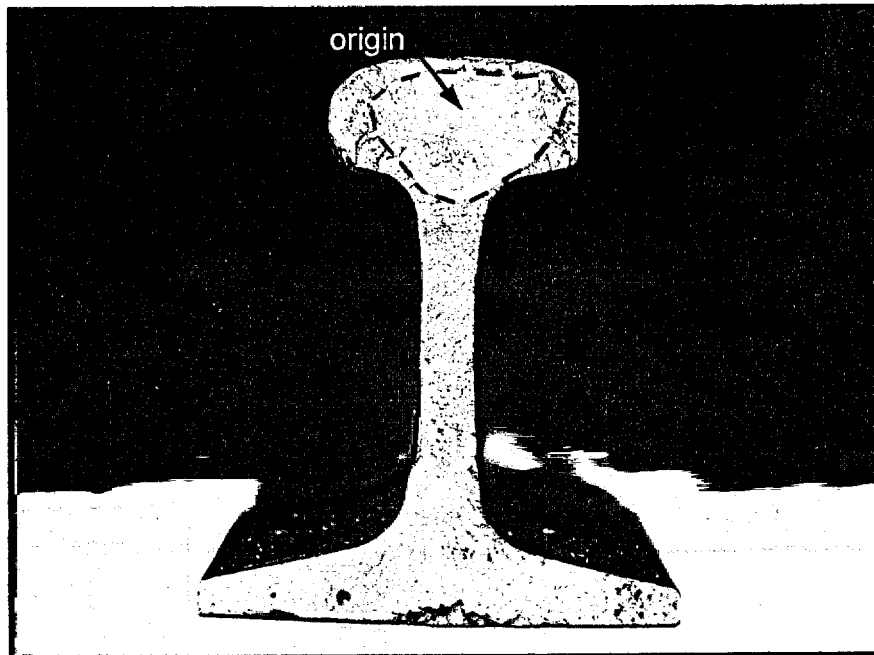
ImageNo:104A0200, Project No:A00182

A view of the east fracture surface at location "b" is shown in figure 3. A portion of the fracture surface within the dashed-line boundary appeared relatively smooth with curving crack arrest lines, features consistent with fatigue. The fatigue features covered approximately 80 percent of the head area and emanated from an origin located 0.625 inches below the running surface approximately on the centerline. A portion of the fatigue region was noticeably smoother than the rest, having a diameter of approximately 0.563 inches centered on the origin. The remaining fracture surface outside the fatigue boundary was relatively rough with chevron marks pointing back toward the fatigue boundary, features consistent with overstress fracture initiating from the fatigue boundary. No rail end damage was observed on the east fracture surface.

The west fracture surface features for location "b" were generally obliterated by post-fracture damage consistent with receiving rail end damage. The field and gage sides of the head were missing. The field side of the base was damaged with downward deformation, and a small piece was missing. Some crack arrest lines were observed on the fracture surface that mated with the east side of the fracture.

Figure 3. A view of the east fracture surface at location "b". An arrow and dashed line indicate the fatigue origin and boundary, respectively.

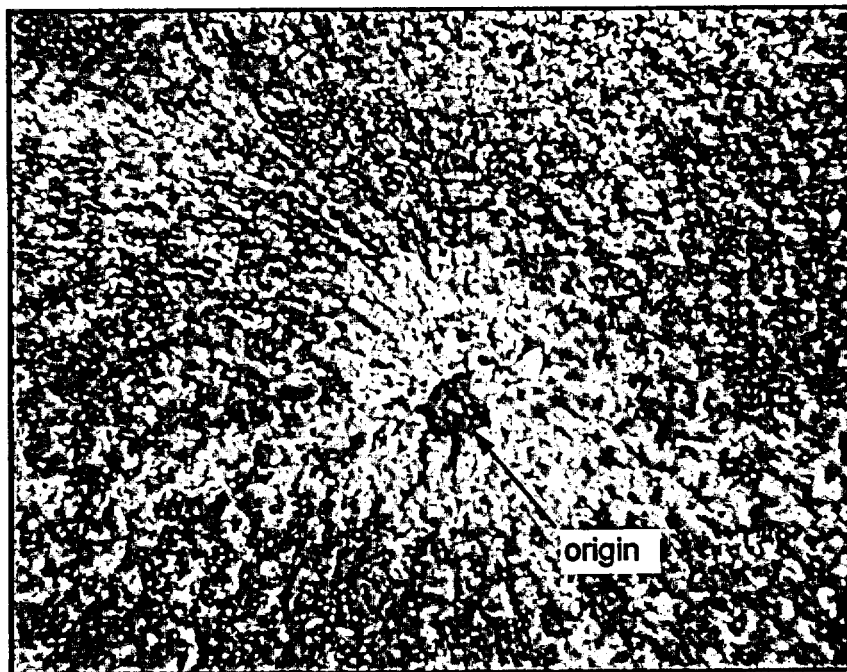
ImageNo: 105A0034, Project No:A00182

The origin area for the east side of the fracture at location "a" is shown at higher magnification in figure 4, appearing dark in the view shown. Crack arrest lines for the relatively smooth fatigue area were observed encircling the origin. The origin as viewed by scanning electron microscopy (SEM) at higher magnification is shown in figure 5, and a dashed line indicates the origin area boundary. The origin had some areas that appeared somewhat granular and other areas that appeared relatively flat. Secondary cracks were also observed in the origin area. Similar features were observed for the origin area at location "b".

Figure 4. A closer view of the origin area on the west fracture surface at location "a".

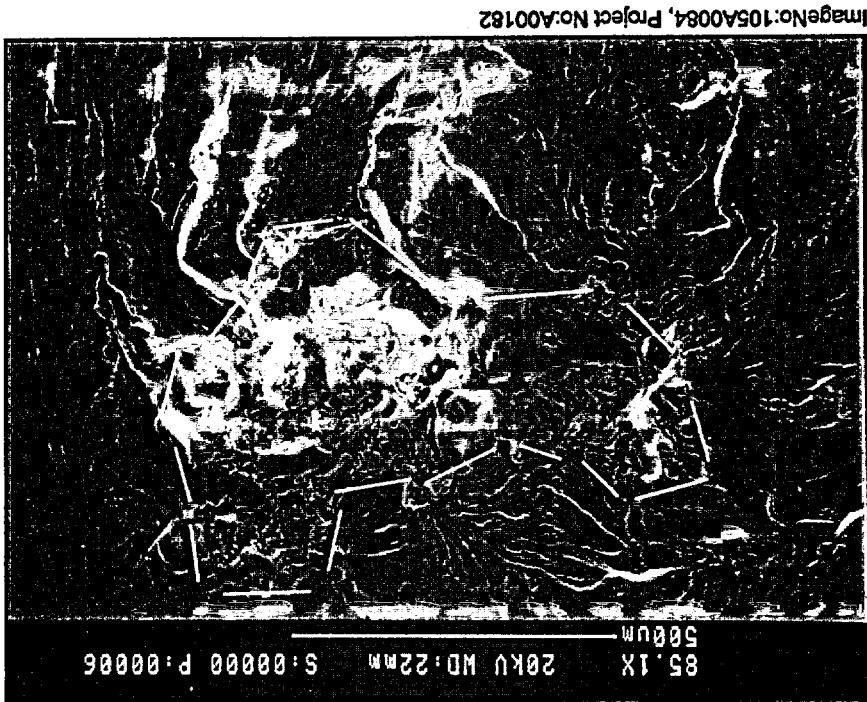
ImageNo:105A0084, Project No:A00182

Figure 5. The origin area on the west fracture surface at location "a" as viewed using SEM. A dashed line indicates the approximate boundary of the origin area.

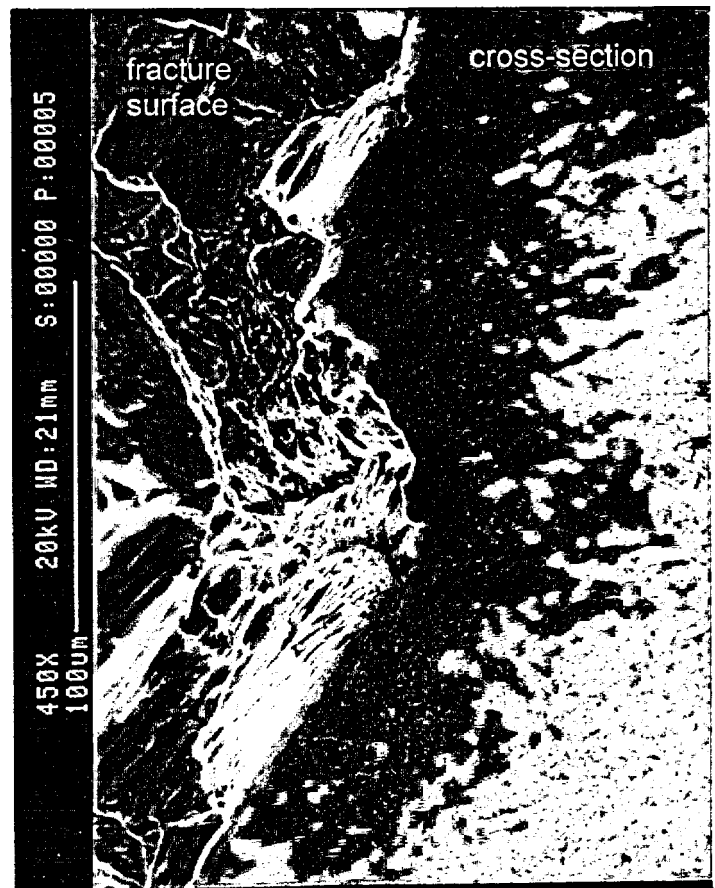
Figure 8. An view of the origin area using SEM at a tilted angle showing the origin area on the fracture surface and the adjacent microstructure in the cross-section.

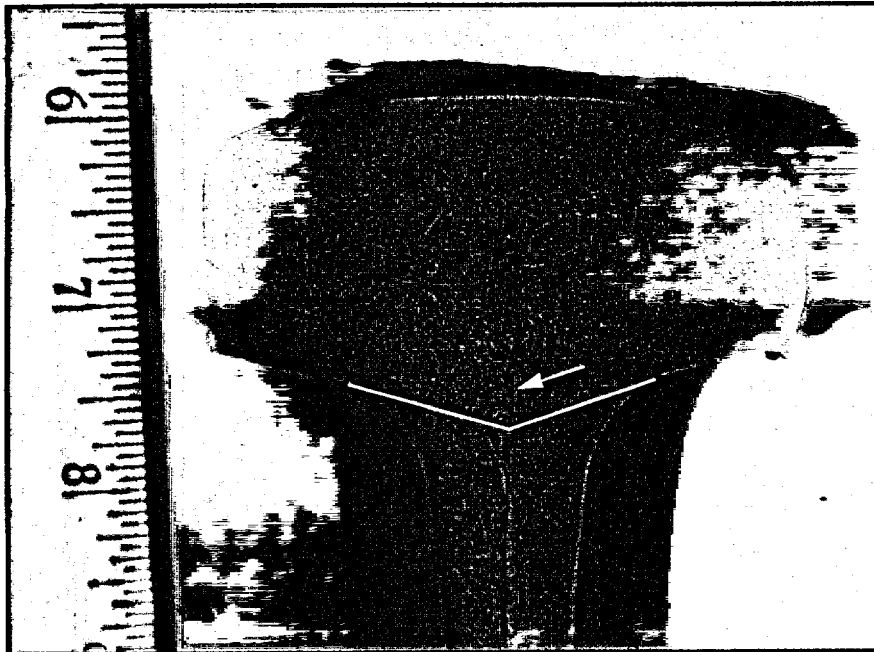
ImageNo:106A0266, Project No:A00182

A transverse and a horizontal section of the rail from piece "B" were macroetched, and the results are shown in figures 9 to 11.⁴ In the transverse section, central web

streaking was observed, and a small amount of streaking extended into the head, as indicated by the arrow in figure 9. Cracks, consistent with cracking associated with internal hydrogen precipitation, were observed in the center of the head as shown in figure 10. Similar cracks were also observed in the center of the base. The average crack length intersecting the transverse plane was 0.0049 inch, and the maximum length observed was 0.012 inch. In the horizontal section, similar cracks were observed, as shown in figure 11. The cracks were observed primarily in the transverse plane and often appeared to be associated with longitudinal inclusions, a feature typical of cracking associated with internal hydrogen precipitation. The average crack length intersecting the horizontal plane was 0.0054 inch, and the maximum length observed was 0.014 inch.

Figure 9. A view of the macroetched rail head from piece "B". A solid line indicates the lower boundary of the head, and an arrow indicates some streaking observed in the head.

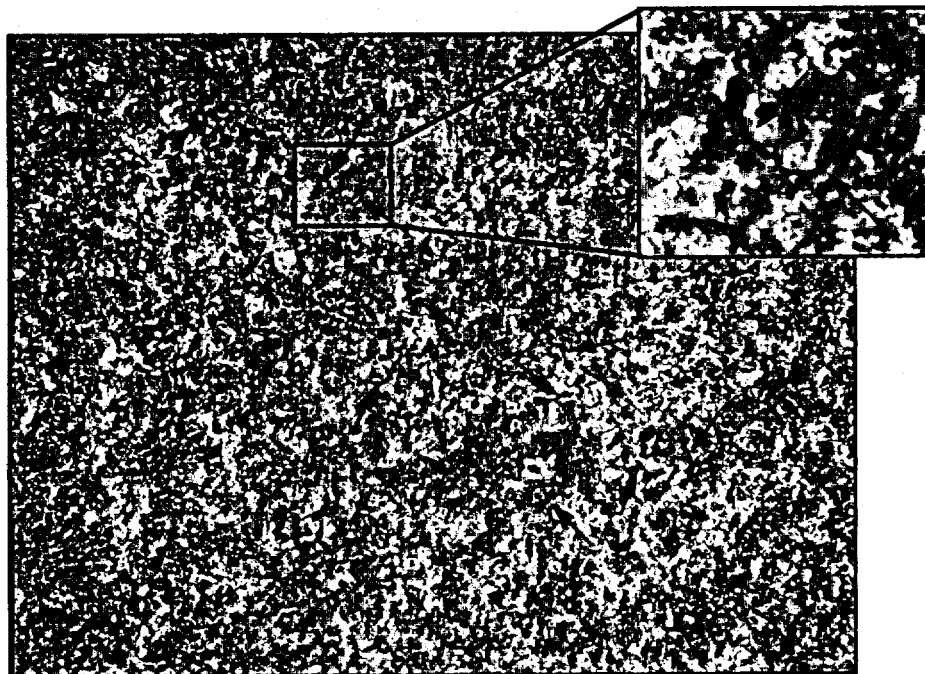
ImageNo: 105A0470, Project No:A00182

Figure 10. A closer view of the macroetched surface on the head shown in figure 9. Arrows indicate some of the observed cracks.

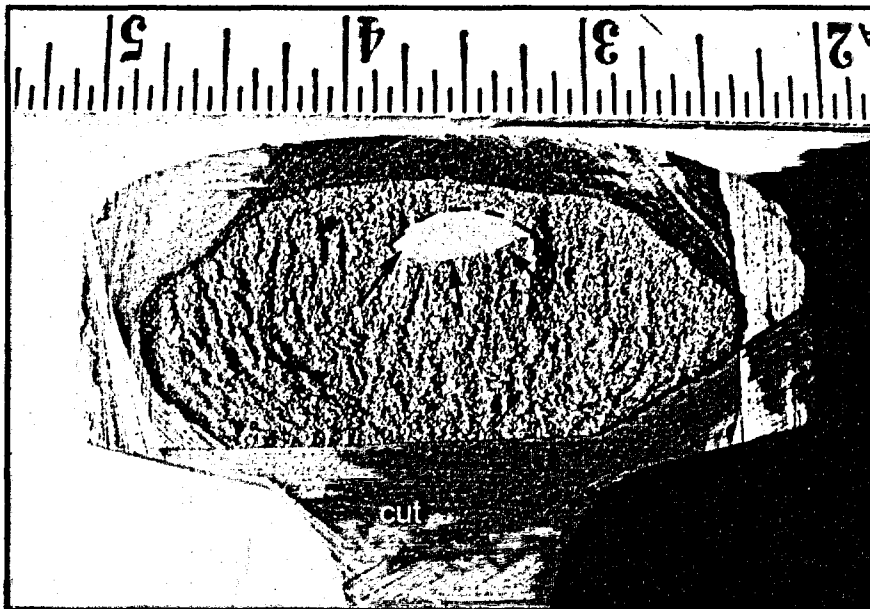
ImageNo: 107A0151, Project No:A00182

The rail was tested using a 70-degree ultrasonic probe along the running surface. No crack indications were observed on rail pieces "A" or "C". However, in rail piece "B", three crack indications were detected near the east end. The ultrasonic testing indicated that two of the cracks were approximately 0.25 inches apart, with the smaller crack located 5.9 inches west of fracture "a" and the larger crack located 5.65 inches west of fracture "a". A transverse cut was made near the location of the smaller crack, leaving most of the head intact. The rail piece was then submerged in liquid nitrogen for a few minutes and then wedged open. The resulting fracture is shown in figure 12. A smooth region, consistent with fatigue, was observed on a portion of the fracture surface on a plane slightly offset from that of the rough overstress fracture. Based on the curvature of crack arrest lines in the fatigue region, the overstress fracture region appeared to intersect the fatigue region at a location just above the origin as indicated by arrows in figure 12. Dashed lines indicate the upper boundary of the fatigue region.

Figure 12. The fracture surface of the rail piece fractured in the laboratory. Arrows indicate the intersection of the overstress fracture with the fatigue region, and a dashed line indicates the upper portion of the fatigue boundary.
