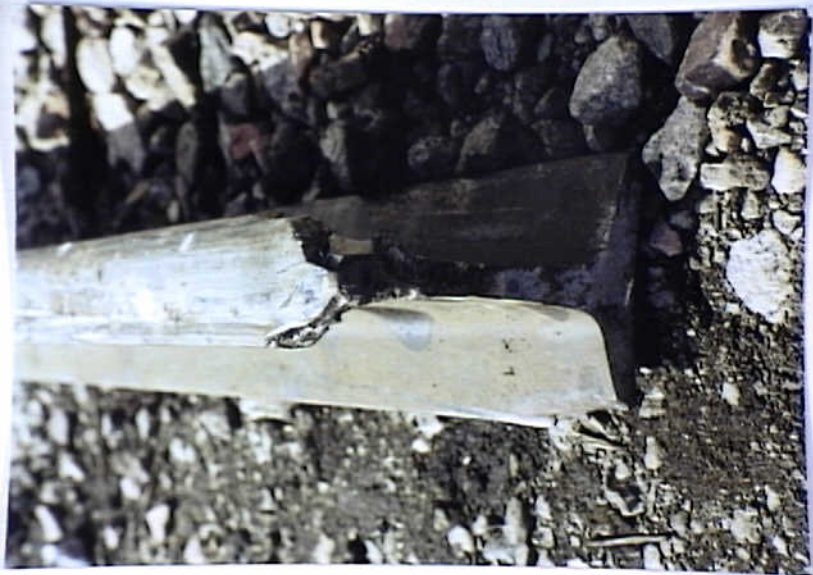
Photo 8. End view of the matching rail face for the second internal defect that measured 98 1/2 inches from the East end bolted rail joint
