NATIONAL TRANSPORTATION SAFETY BOARD
Office of Railroad, Pipeline and Hazardous Material Investigations
Washington, DC 20594

AMTRAK CONSIST

SITE SKETCH

AMTRAK EQUIPMENT DOCUMENTATION

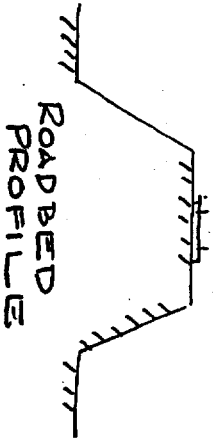
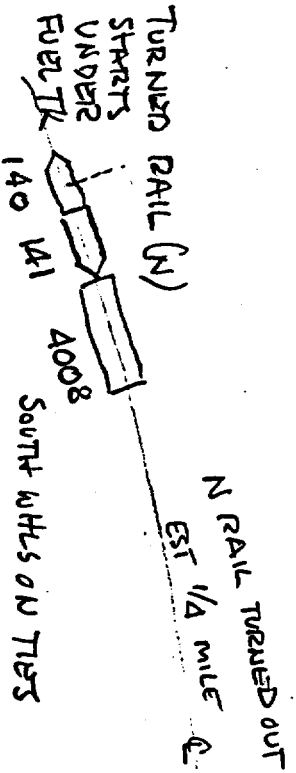
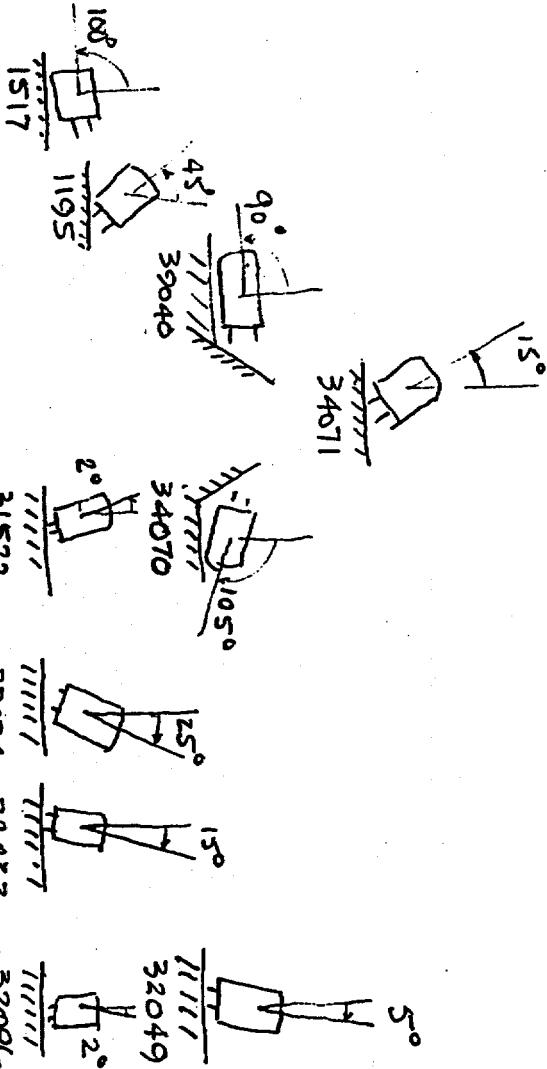
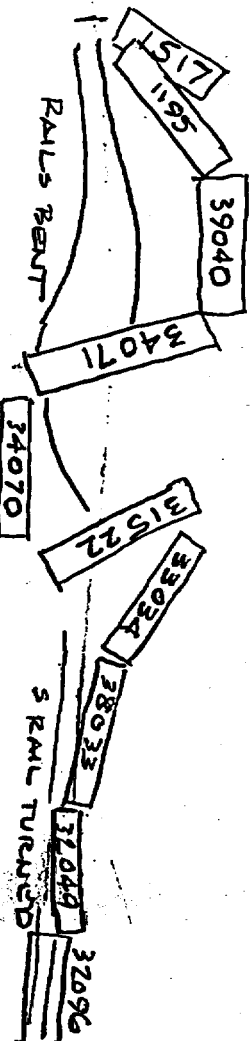
SITE SKETCH

AMTRAK CALIF. BERRY 5(17)
MORAWAY, IOWA MP 419.85
18 MARCH, 2001
BY P.D. HALL

140-R TRUCKS DERAILED ON TURN
141-FTR TRUCKS S "

MAIL/EX CARLS NOT DR.

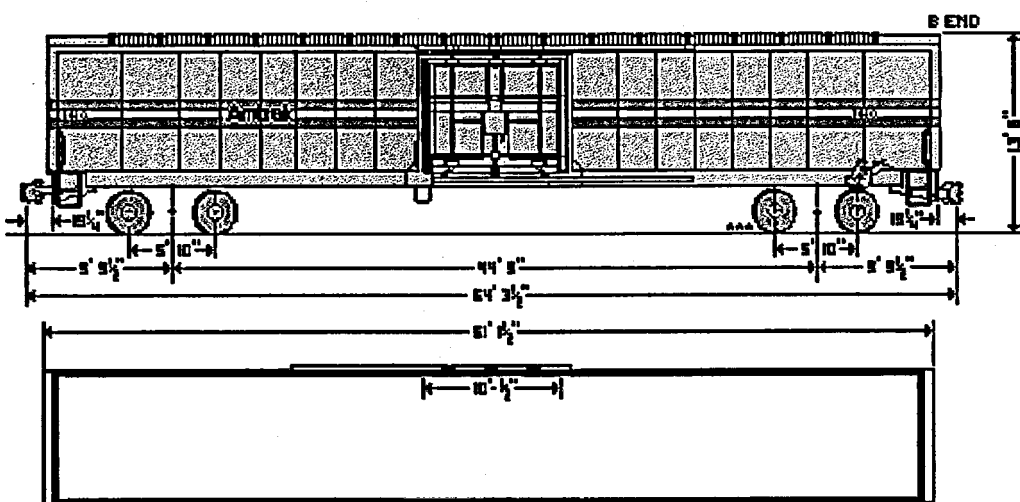
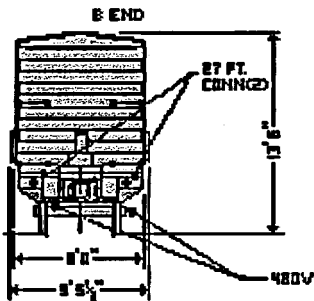
500 1517
MATERIAL HANDLING CAR 1400

UNDERBODY VIEW THROUGH FLOOR

SIDE/END DAMAGE
BAGGAGE CAR RESTING ON TOP
OF L SIDE

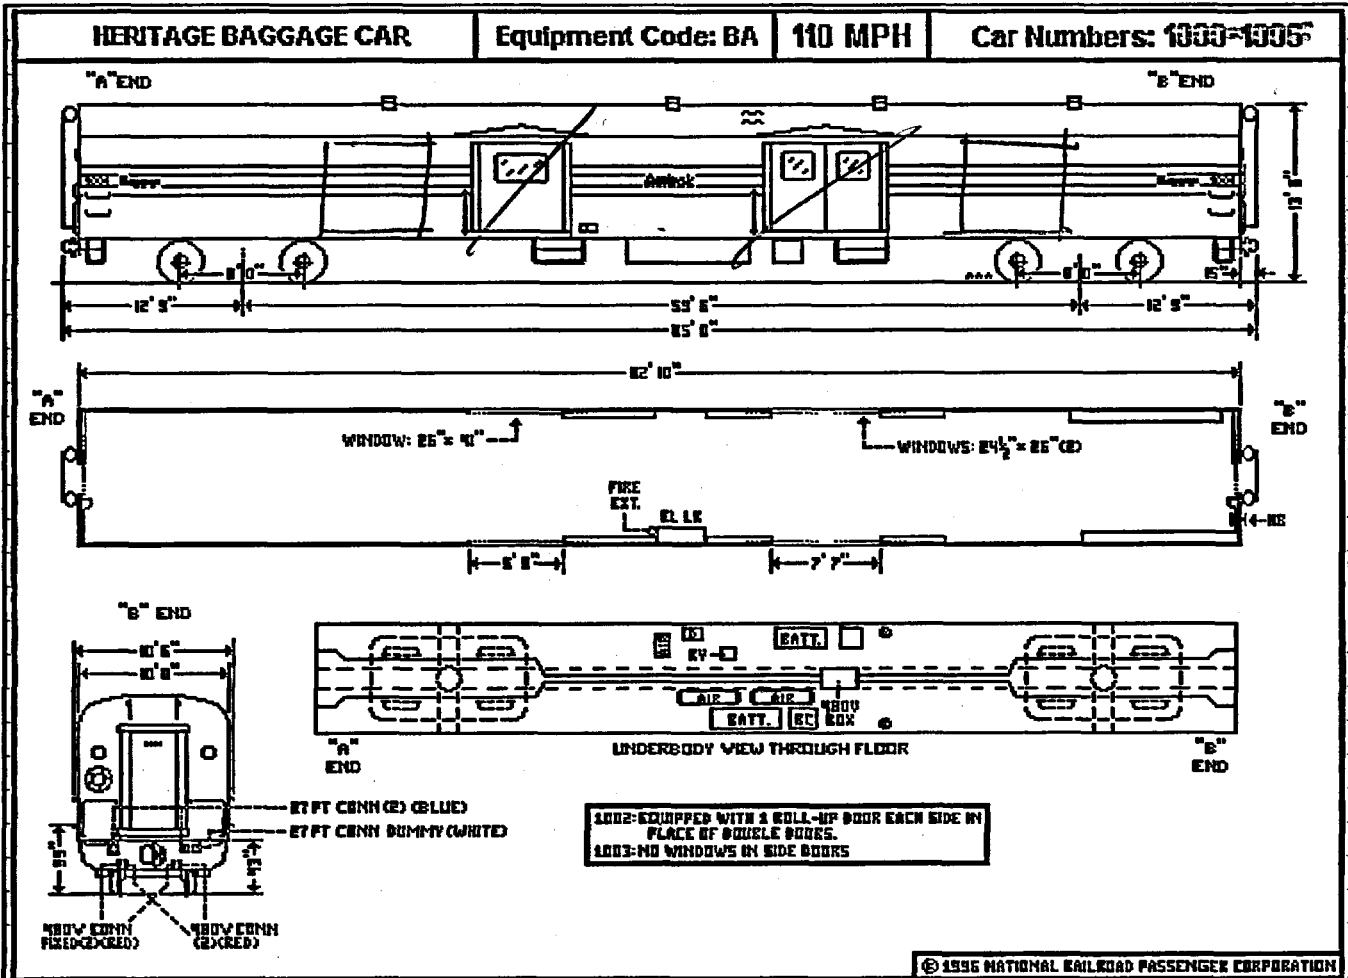
1195

Final Orientation / General Exterior Condition: ON SIDE / ON TOP OF 1517 / IN DITCH

RESTING ON TOP OF 1517

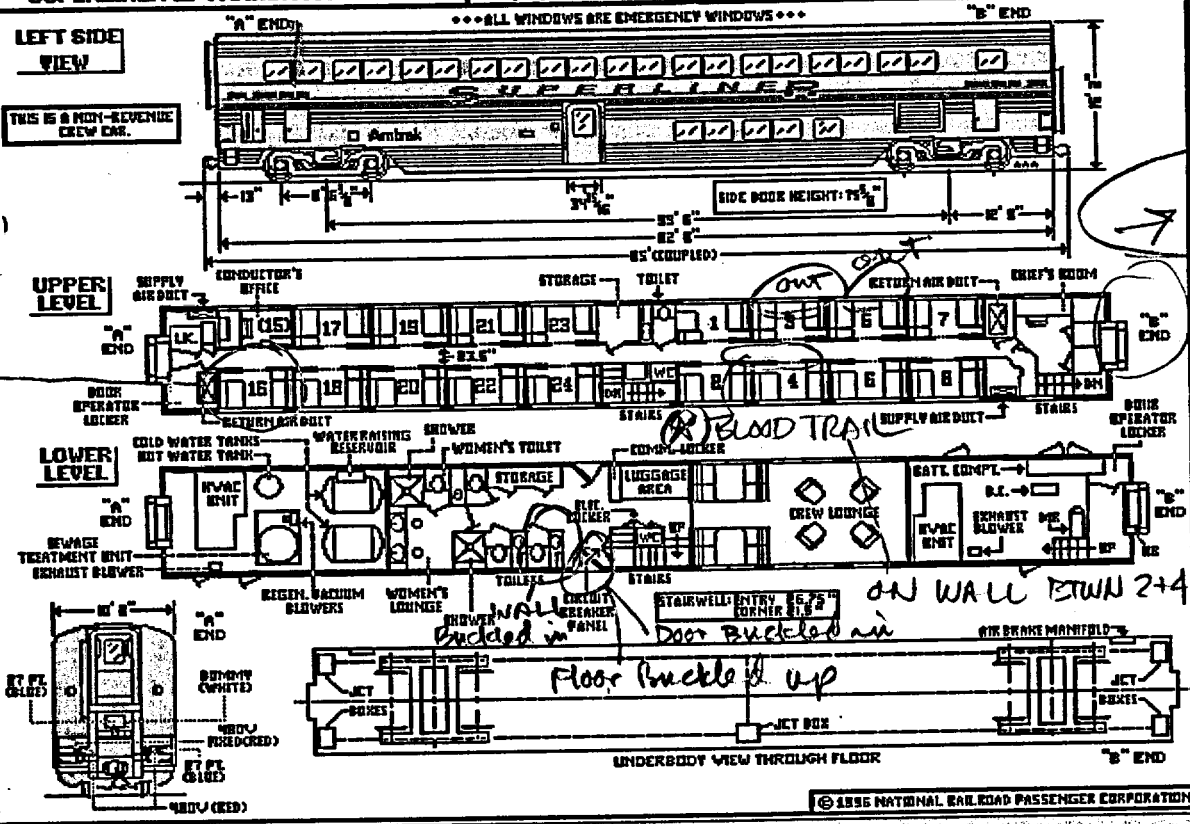
39040

NOT BEDROOM
LABORATORY
SIGNIFICANT
INTRUSION
OF FENCE
POST

NAIL
BTW
2nd
floor
B. bed

ITEM	REMARKS	ITEM	REMARKS
Lavatories/Mirrors	INTRUSION IN #16 LAV - FENCE POST THROUGH WALL	Emergency Tools	
Doors/Beds/Walls		Maul	OK
Room # 1	BUNK UP	Pry Bar	MISSING
Room # 2	Bunk down	First Aid Kit	MISSING
Room # 3	BUNK UP WINDOW OUT	Light Sticks	OK
Room # 4	Blood on door / door jammed open	Fire Extinguisher	OK 3/1/01 OK
Room # 5	BUNK UP WINDOW OUT	Date:	
Room # 6		Doors	
Room # 7		End Door "A" End	OK - open
Room # 8	DOOR OFF TRACK	End Door "B" End	OK - closed
Room # 9		Location of Seriously Injured Persons (if known)	NTM
Room # 10	N/A	Other (Specify)	
Room # 11			
Room # 12			
Room # 13			
Room # 14			
Room # 15	OK - pocket wall at bottom 3"		
Room # 16	Shower/toilet		
Room # 17	BUNK UP LOCKED w/ LUGGAGE / DISAP - WALL AS IS	End Crash Bars	
Room # 18	BUNK UP EMPTY OPEN	A End	OK
Room # 19	OK - one cushion in 18	B End	OK
Room # 20	OK - Door window broken	Emergency Signage	
Room # 21	OK - 1 seat cushion in 22	Interior	OK

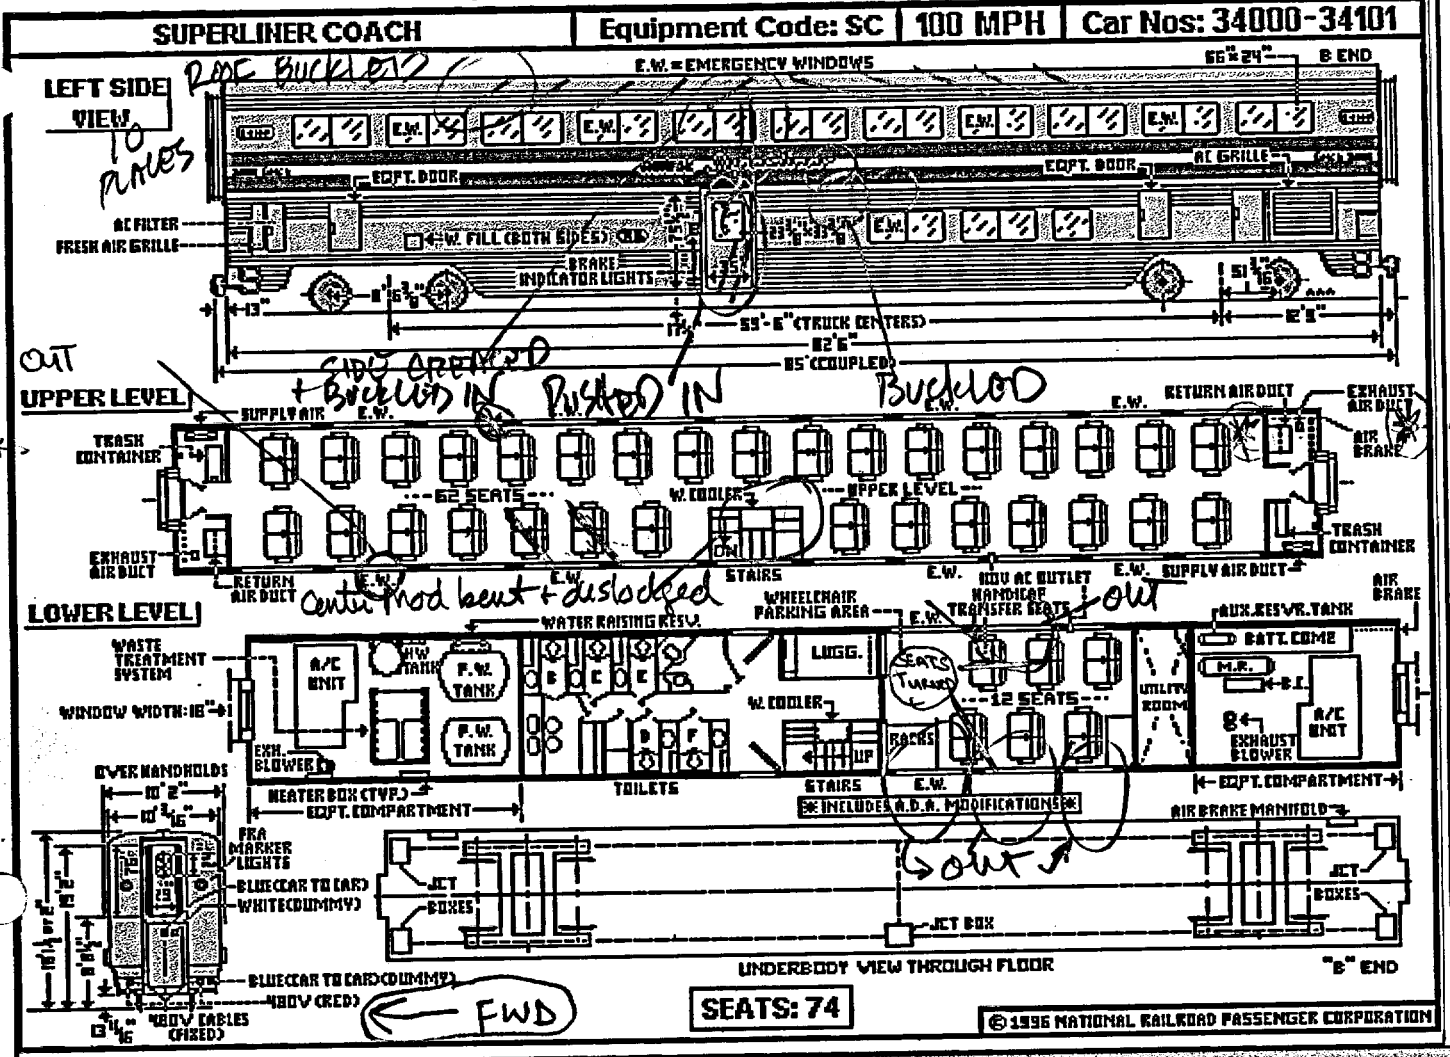
32071

Center Module - bent/buckled / upper cabinet panel + water panel

ITEM	REMARKS	ITEM	REMARKS
Lavatories	HANDICAP. Lava. Door BENT	Emergency Tools	
LAVATORY F. sign. INTRUSION FROM OUTSIDE	BOTTOM EDGE BUCKLED / FLR.	Maul	MISSING
FIXTURES BROKEN	BUCKLED UP APPROX 4"	Pry Bar	OK ✓ here (LOOSE)
WATER MODULE BENT	HALLWAY WALL MOVED SIDEWAYS APPROX 9"	First Aid Kit	OK ✓
Mirrors	OK	Light Sticks	
FIXTURES	IN PLACE	Fire Extinguisher	OK 3/1/01 OK
HANDICAP MIRROR	DISLODGED IN VESTIBULE BROKEN LOWER LEFT CORNER	Date:	
Luggage Racks/ Dividers		Doors	
		Entry, Eng.'s Side	JAMMED OPEN BY STEP BOX
		Entry, Fire.'s Side	SIGNIFICANT INTRUSION APPROX 1 FT INTO VESTIBULE - FLR BUCKLED 6 IN. UPWARD
Emergency Signage		Location of Seriously Injured Persons (If known)	NOT KNOWN
Interior			
Exterior			
Batteries & Box		Other (Specify)	
Condition of Batteries	NOT AVAILABLE - DOWN SIDE	Step Box	OK here
Battery Retention		ADA ramp	IN PLACE
Device		ADA retention strap	OK IN PLACE
		End Crash Bars	
		"A" End

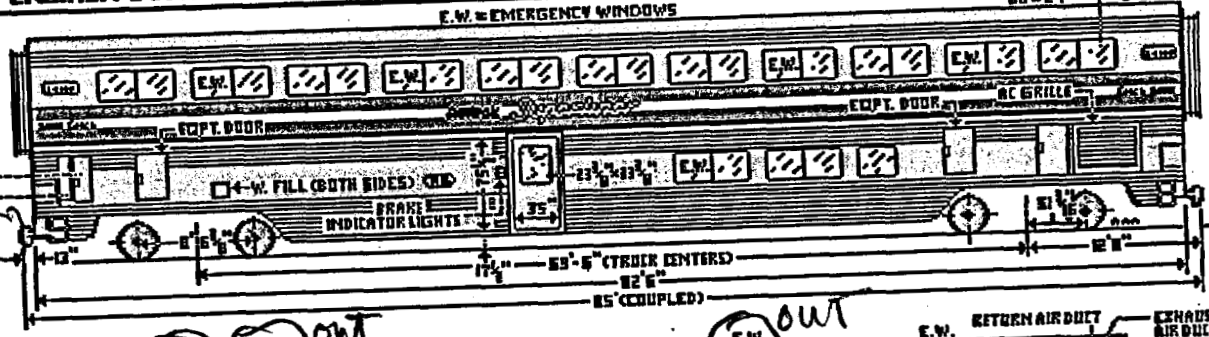
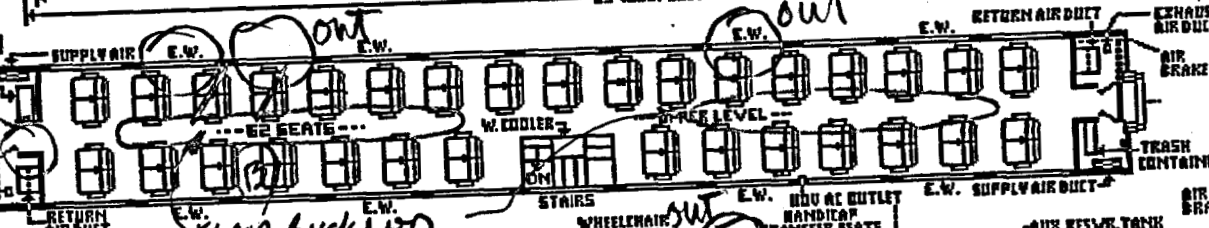
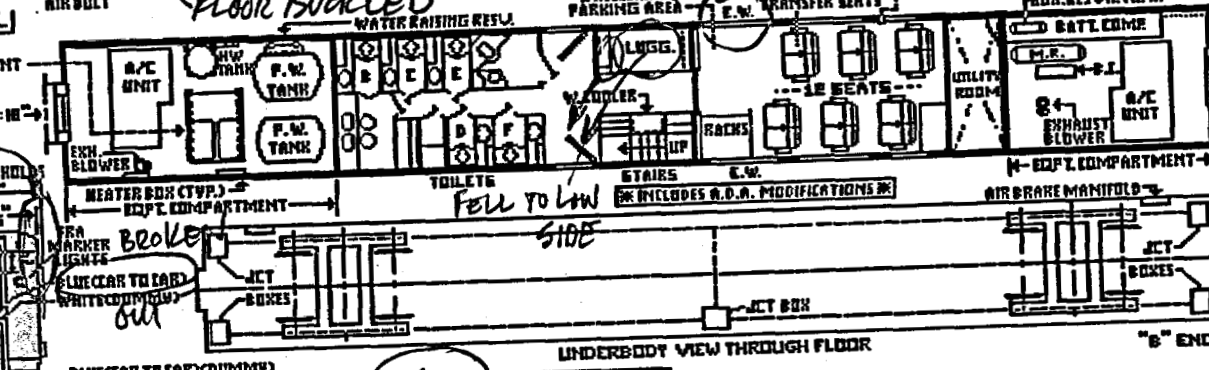
34070

ITEM	REMARKS	ITEM	REMARKS
Lavatories	JAMMED SHUT	Emergency Tools	
		Maul	✓
		Pry Bar	✓
		First Aid Kit	✓
		Light Sticks	✓
Mirrors	/	Fire Extinguisher	✓
	MID-CAR RACK DROPPED TO LOW SIDE	Date:	1/3/01
Luggage Racks/ Dividers	CEILING BUCKLED ABOVE LUGGAGE RACKS - LT SIDE	Doors	
	RACKS BROKEN - LT SIDE	Entry, Eng.'s Side	
Emergency Signage	OK	Entry, Fire.'s Side	DOWN ON SIDE
Interior	OK	Location of Seriously Injured Persons (If known)	/
Exterior	OK		
Batteries & Box		Other (Specify)	
Condition of Batteries		Step Box	OK
Battery Retention		ADA ramp	Dropped to low side
Device		ADA retention strap	Gone
		End Crash Bars	
FRAME	CEILING SHOWS WAVES	"A" End	
		"B" End

STILL ATTACHED TO 34071 KNUCKLE

WALL PUSHED IN

PUSHED IN

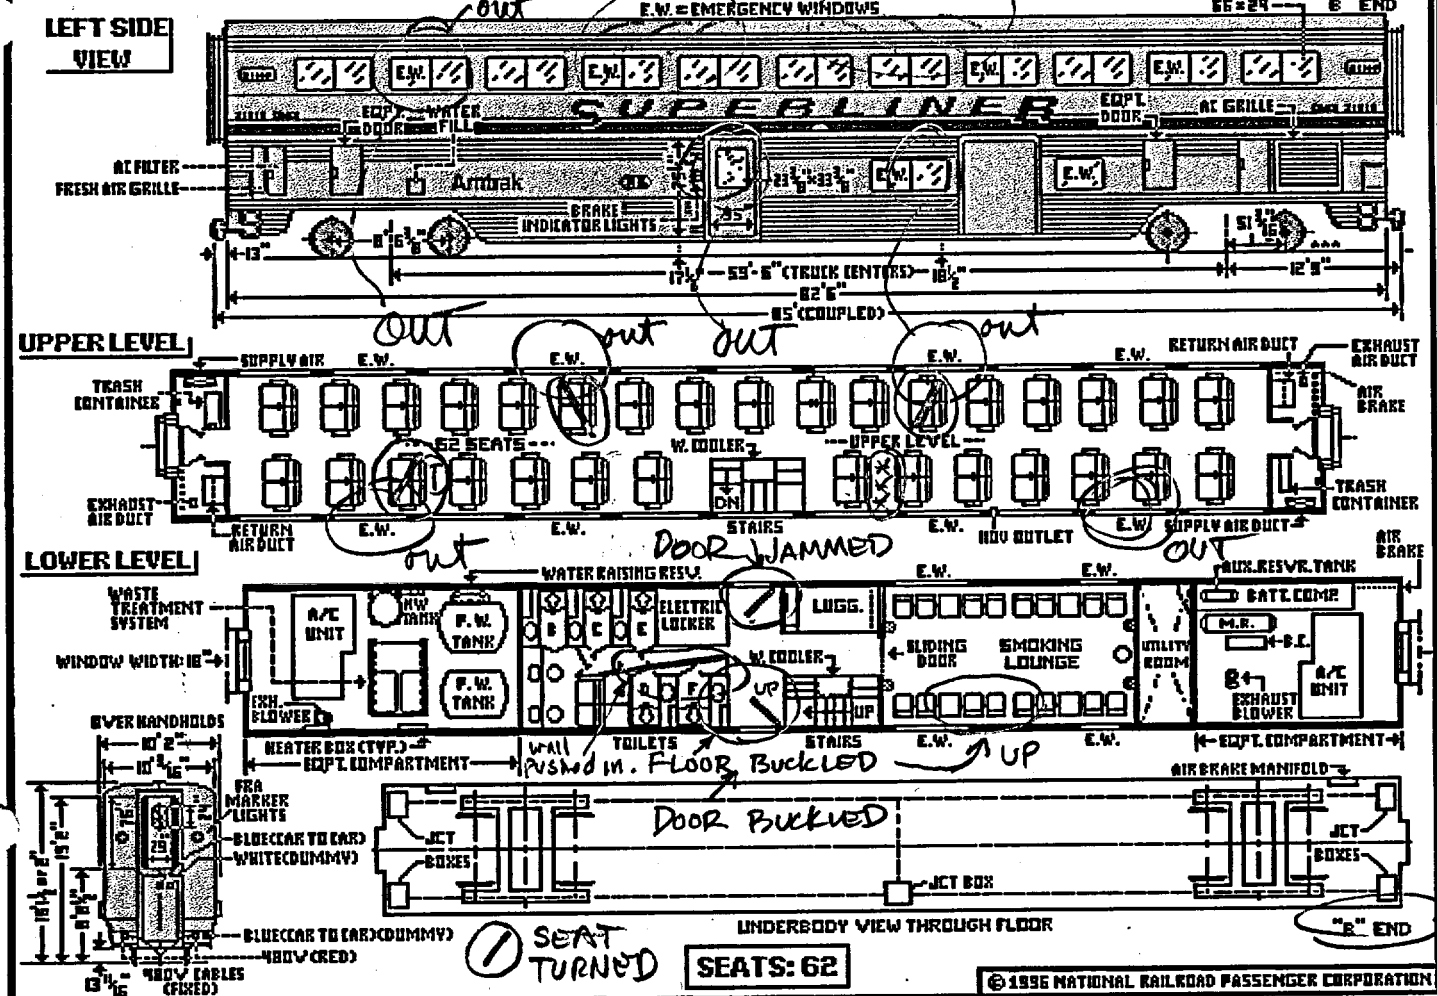
SUPERLINER COACH/SMOKING CAR

Damaged and or Missing (Explain) **See diagram**

ITEM	REMARKS	ITEM	REMARKS
Lavatories		Emergency Tools	
A	ALL DOORS JAMMED DUE CAR ON SIDE	Maul	✓
B		Pry Bar	✓
C		First Aid Kit	✓
D		Light Sticks	✓
E		Fire Extinguisher	✓
F		Date:	
Mirrors		Doors	
A	/	Entry, Eng.'s Side	Damaged - dents
B		Entry, Fire.'s Side	Damaged - buckled
C		Entry Door to Smoking Area	Jammed @ angle - lower edge forward.
D		Restroom Doors	
E		A	
F		B	
Luggage Racks/ Dividers	ok	C	
Emergency Signage		D	
Interior	ok	E	
Exterior	ok	F	
End Crash Bars		Location of Seriously Injured Persons (If known)	None noted
A End	ok		
B End	ok	Other (Specify)	
		Step Box	N/A
		ADA ramp	N/A
		ADA retention strap	N/A
Emerg. Evac. Cards	NOT APPLICABLE

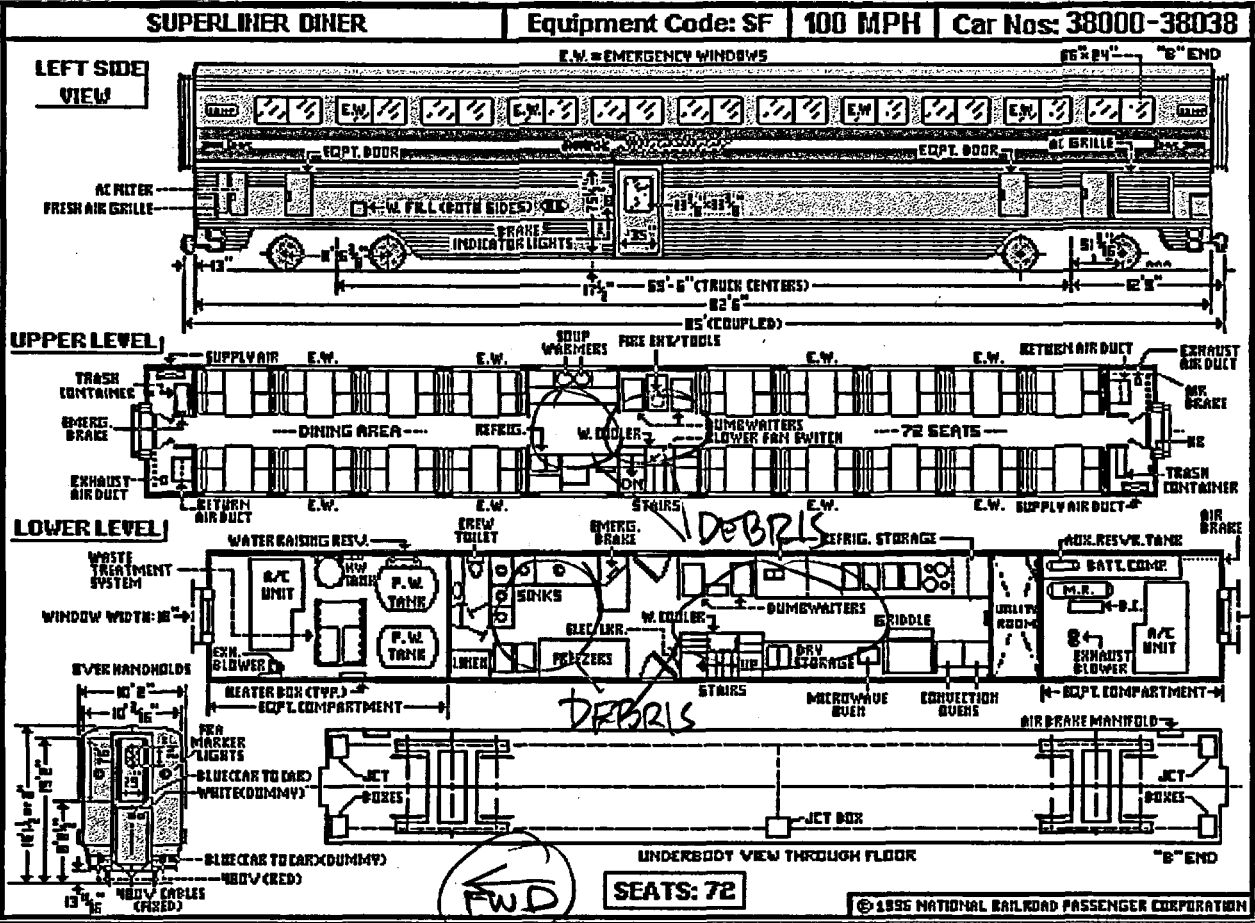
SUPERLINER I DINER

ITEM	REMARKS	ITEM	REMARKS
Ovens/Microwaves	<u>In place</u> <u>one door open - At Side</u>	Emergency Tools	<input checked="" type="checkbox"/>
		Maul	<input checked="" type="checkbox"/>
		Pry Bar	<u>NO</u>
		First Aid Kit	<u>NO</u>
Stove	<u>ok In place</u>	Light Sticks	<u>NO</u>
		Fire Extinguisher	<u>NO</u>
		Date:	
Cabinets	<u>closed</u>	Doors	
		Entry, Eng.'s Side	<u>ok</u>
		Entry, Fire.'s Side	<u>ok - entry for Insup.</u>
Emergency Signage		Refrigerator Doors	<u>all ok</u>
Interior	<u>ok</u>		
Exterior	<u>ok</u>	Cabinet Doors	<u>all ok</u>
		Lavatory Door	<u>ok</u>
End Crash Bars		Location of Seriously Injured Persons (if known)	<u>NONE</u>
A End	<u>ok</u>		
B End	<u>ok</u>		
Batteries & Box		Other (Specify)	
Condition of Batteries	<u>unavailable -</u> <u>steep hill</u>	Stock	<u>all loose stock in disarray</u>
Battery Retention Device
